OHIO HISTORIC INVENTORY

1. No. 104 FRA-3785-10		4. Present Name(s) THE PIERCE RESIDENCE		1. No. 3785-10	
2. County FRANKLIN		5. Other Name(s) IN THE PIERCE FAMILY SINCE 1920, DOLL			2. County FRANKLIN

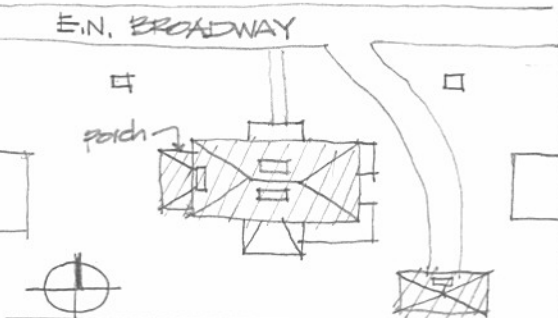
8. Site Plan with North Arrow

44. Description of Environment and Outbuildings ON SOUTH SIDE OF THE TREE LINED N. BROADWAY STREET OPPOSITE UNITED METHODIST CHURCH. VERY CLEAN SIMPLE LANDSCAPE. ESTABLISHED NEIGHBORHOOD IN BACK ARE THE GARAGE AND A WROUGHT-IRON GAZEBO (SMALL)				41. Distance from and Frontage on Road 63' - 81'
