# OHIO HISTORIC INVENTORY

1. No. <b>FRA-3412-10</b>	4. Present Name(s) Mitchell, Thomas & Gail, house	1. No. <b>3412-10</b>	
2. County Franklin	5. Other Name(s)		2. County FRANKLIN
3. Location of Negatives Col. Dept. of Jobs Devel.

6. Specific Location  23 Riverview Park Drive	16. Thematic Category D	28. No. of Stories 1½	4. Present Name(s) MITCHELL, THOMAS & GAIL										
	17. Date(s) or Period 1922	29. Basement? Partial Yes <input checked="" type="checkbox"/> No <input type="checkbox"/>											
7. City or Town If Rural, Township & Vicinity Columbus	18. Style or Design English Cottage	30. Foundation Material Stone	5. Other Name(s)										
8. Site Plan with North Arrow

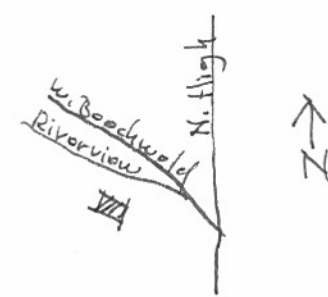
44. Description of Environment and Outbuildings Faces ravine park, east end of lot near High St. One side of old stone bridge at edge of property - n.e. Many large old trees. Vacant lot to west belonged to owners of this house until 1976. Originally contained large elms. Garage, shed (remodeled chicken house)
---
